ROOF WRITTEN BY ROBERT SITERLET RE-COVER

AN ASBESTOS-LADEN ROOFING PRODUCT ON A FOUNDRY IS COVERED, RATHER THAN ABATED

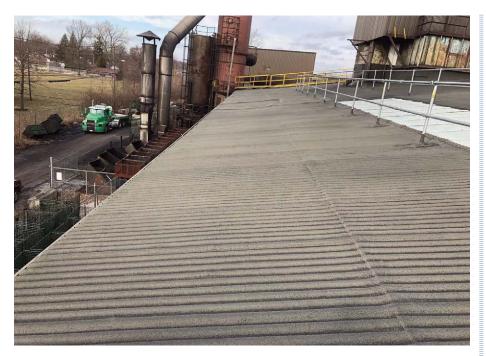
AFTER: FASTENERS AND LAP JOINTS ARE NO LONGER SUSCEPTIBLE TO WATER ENTRY WITH THE NEW MEMBRANE OF THE RE-COVER SYSTEM LAMINATED TO THE TRANSITE PANELS.

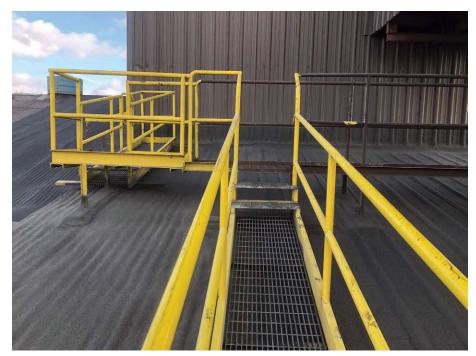
AN ACCESS WALKWAY AND ITS POSTS AND PENETRATIONS WERE SEALED WITH THE RE-COVER SYSTEM.
